## SAMPLING FOR PEPTIDE BONDS & PROTEINS

## Case Study: San Francisco Home

## Case Study: Atherton Home

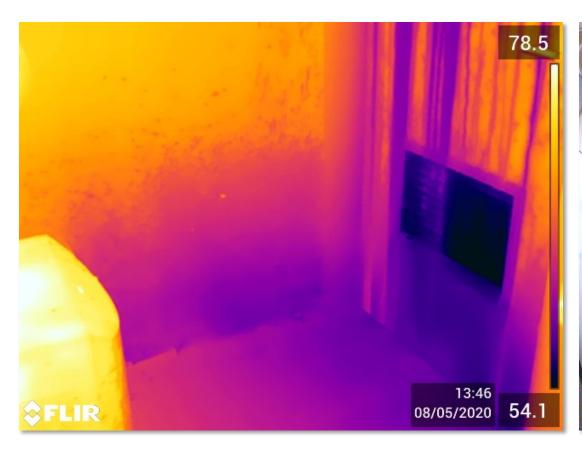
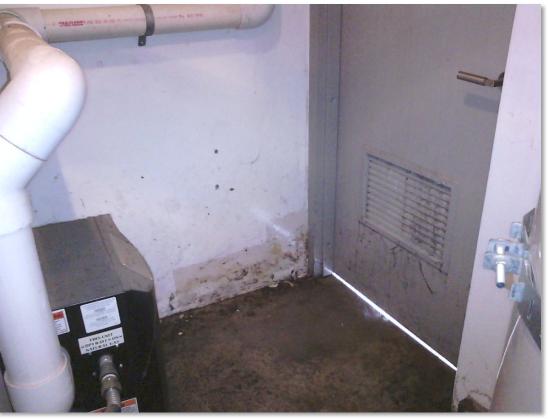
## Findings - Water Testing Outside of Boiler Room Reveals Gross Amount of Water Intrusion

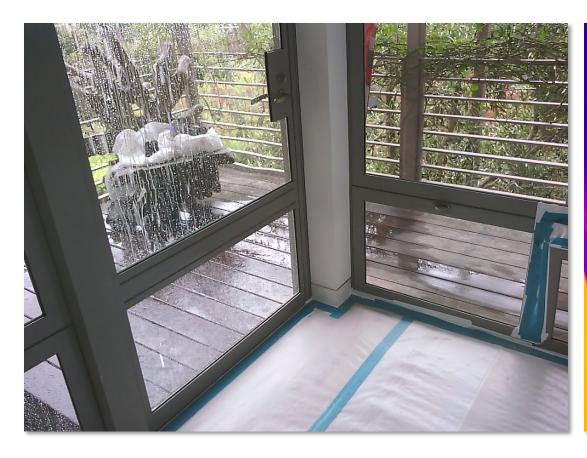
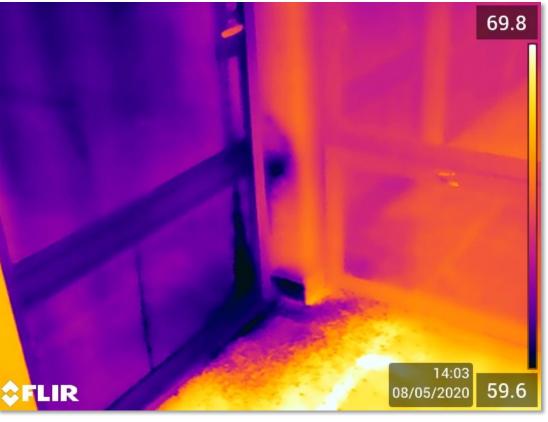
## Findings – Targeted Water Testing Reveals Intrusion into Various Doors and Windows

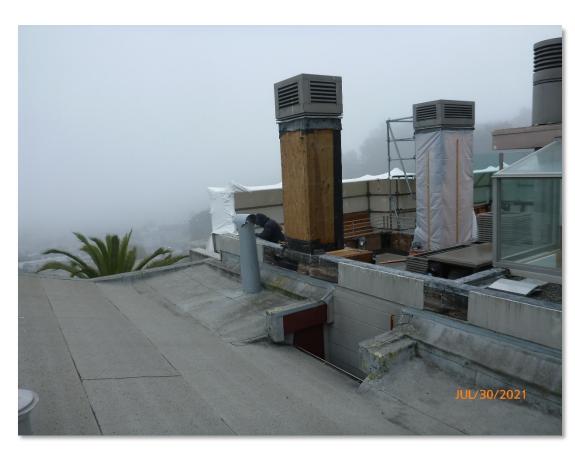
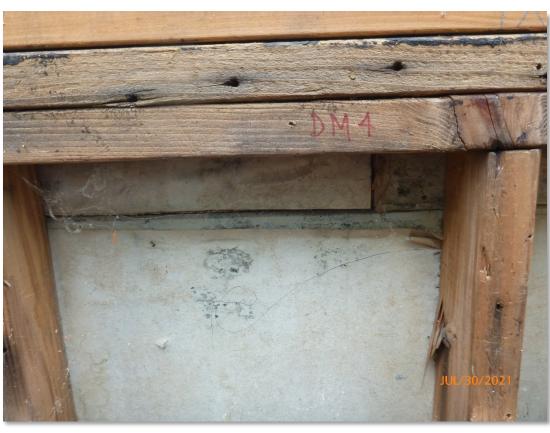
## North Elevation – Yellow Areas

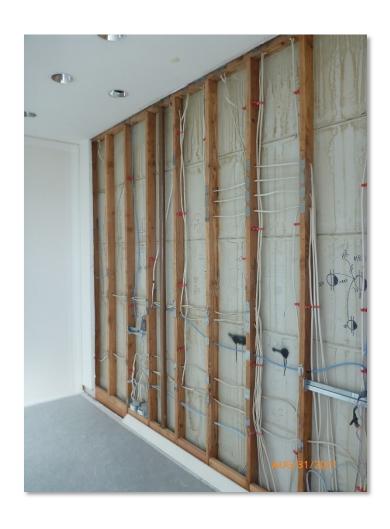
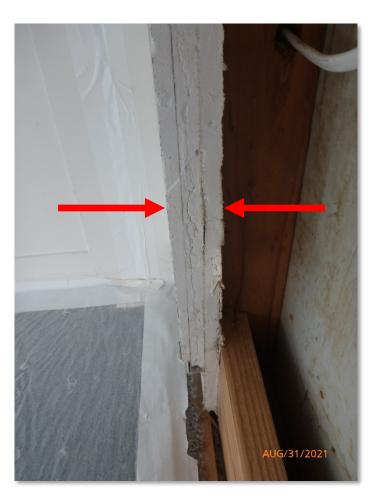
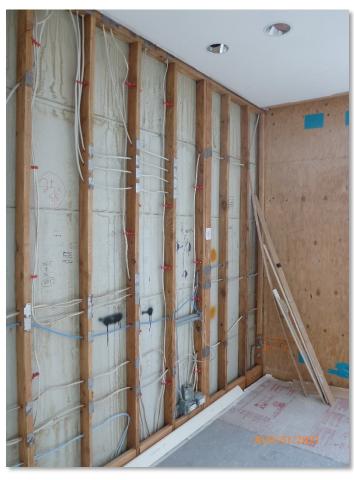
## North Elevation – Yellow Areas

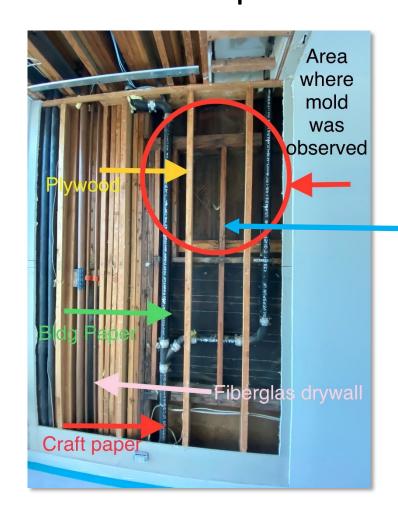
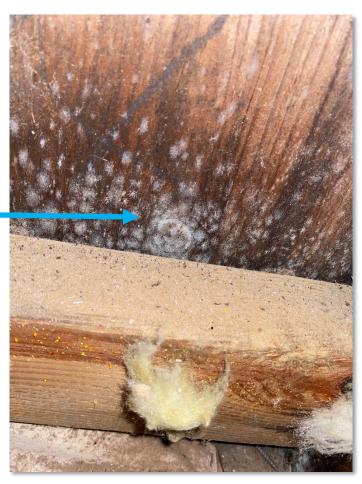
## North Elevation Prompts South Elevation Inspection

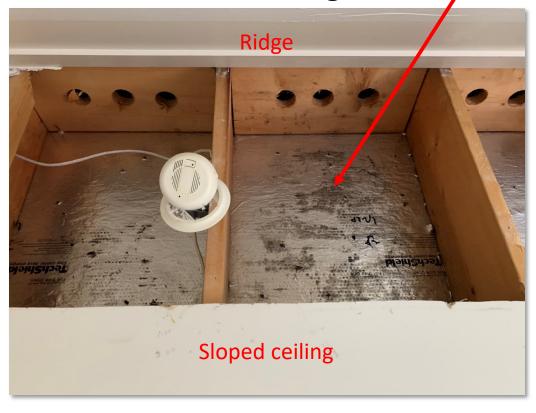
#### **Unvented Vaulted Ceilings**

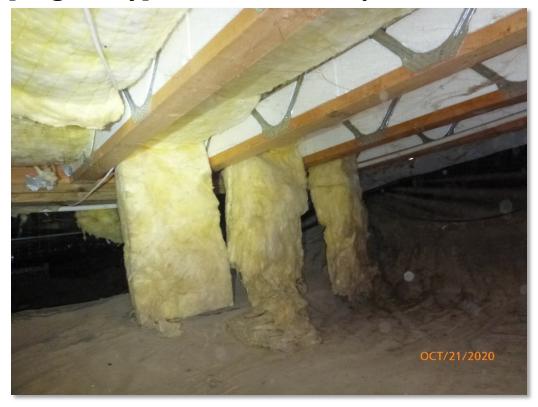
#### [Regularly] Flooded Crawlspace

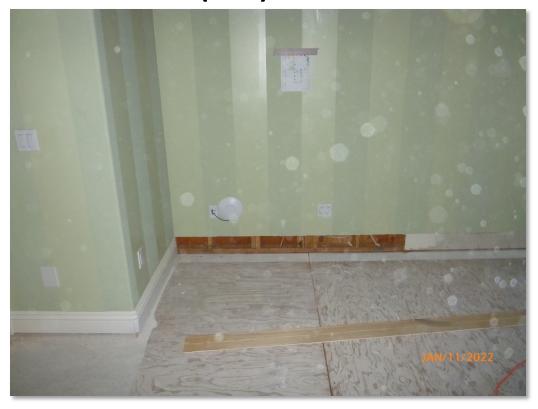
#### **Bedroom wall (Red)**

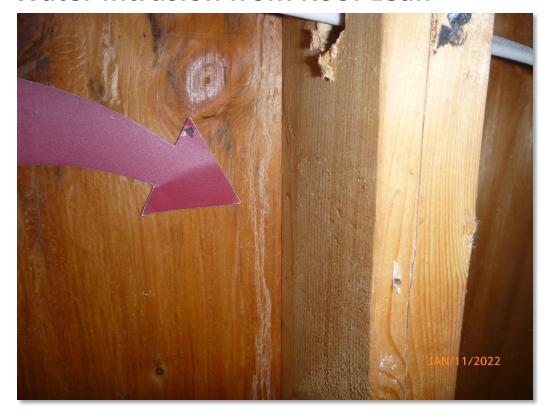
#### **Water Intrusion from Roof Leak**

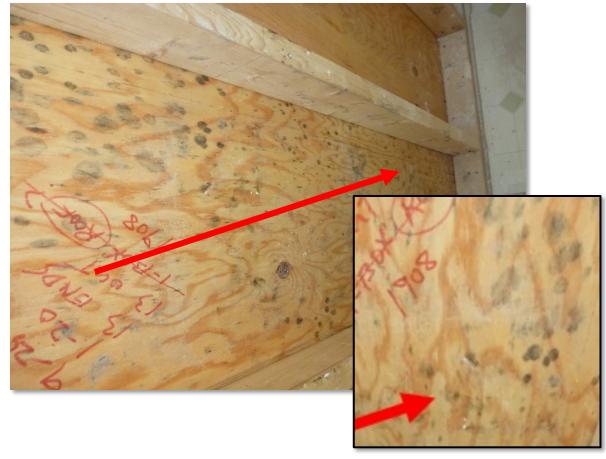
Bathroom wall (Orange)

Mold on Original Plywood

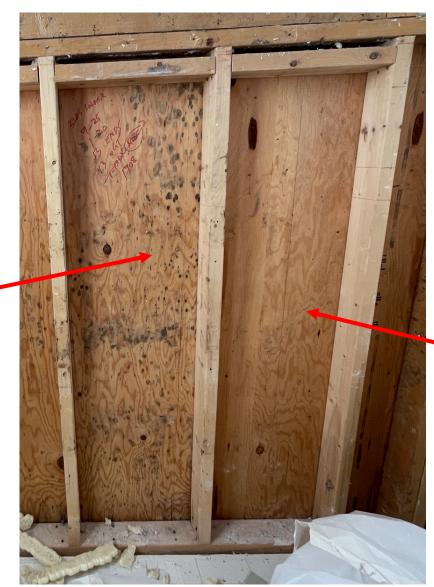
Plywood Identified by Pathways Testing

(9 Areas)

Plywood presumed wet during construction

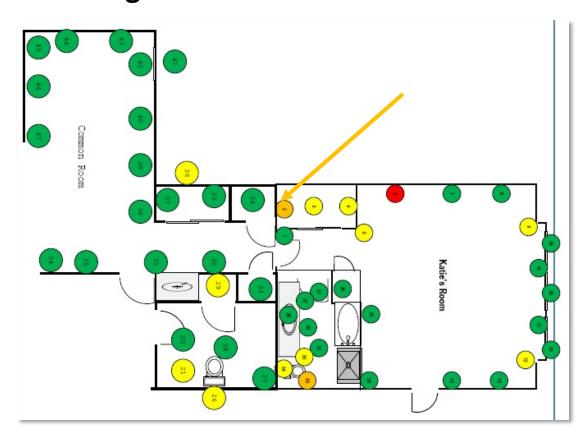
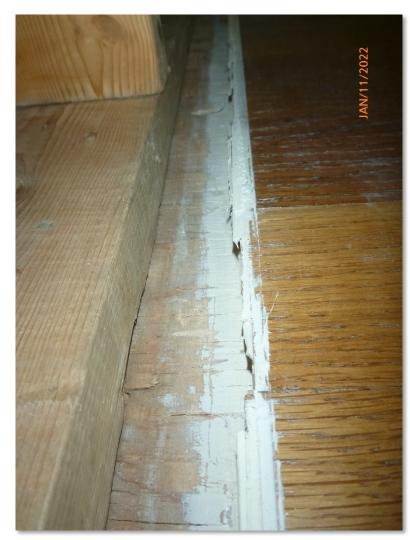
#### **Washing Machine Overflow from 2013**
